**Tanner's Creek Fly Ash  
Pond Assessment Report**

**Lockheed Martin**

**June 2009**

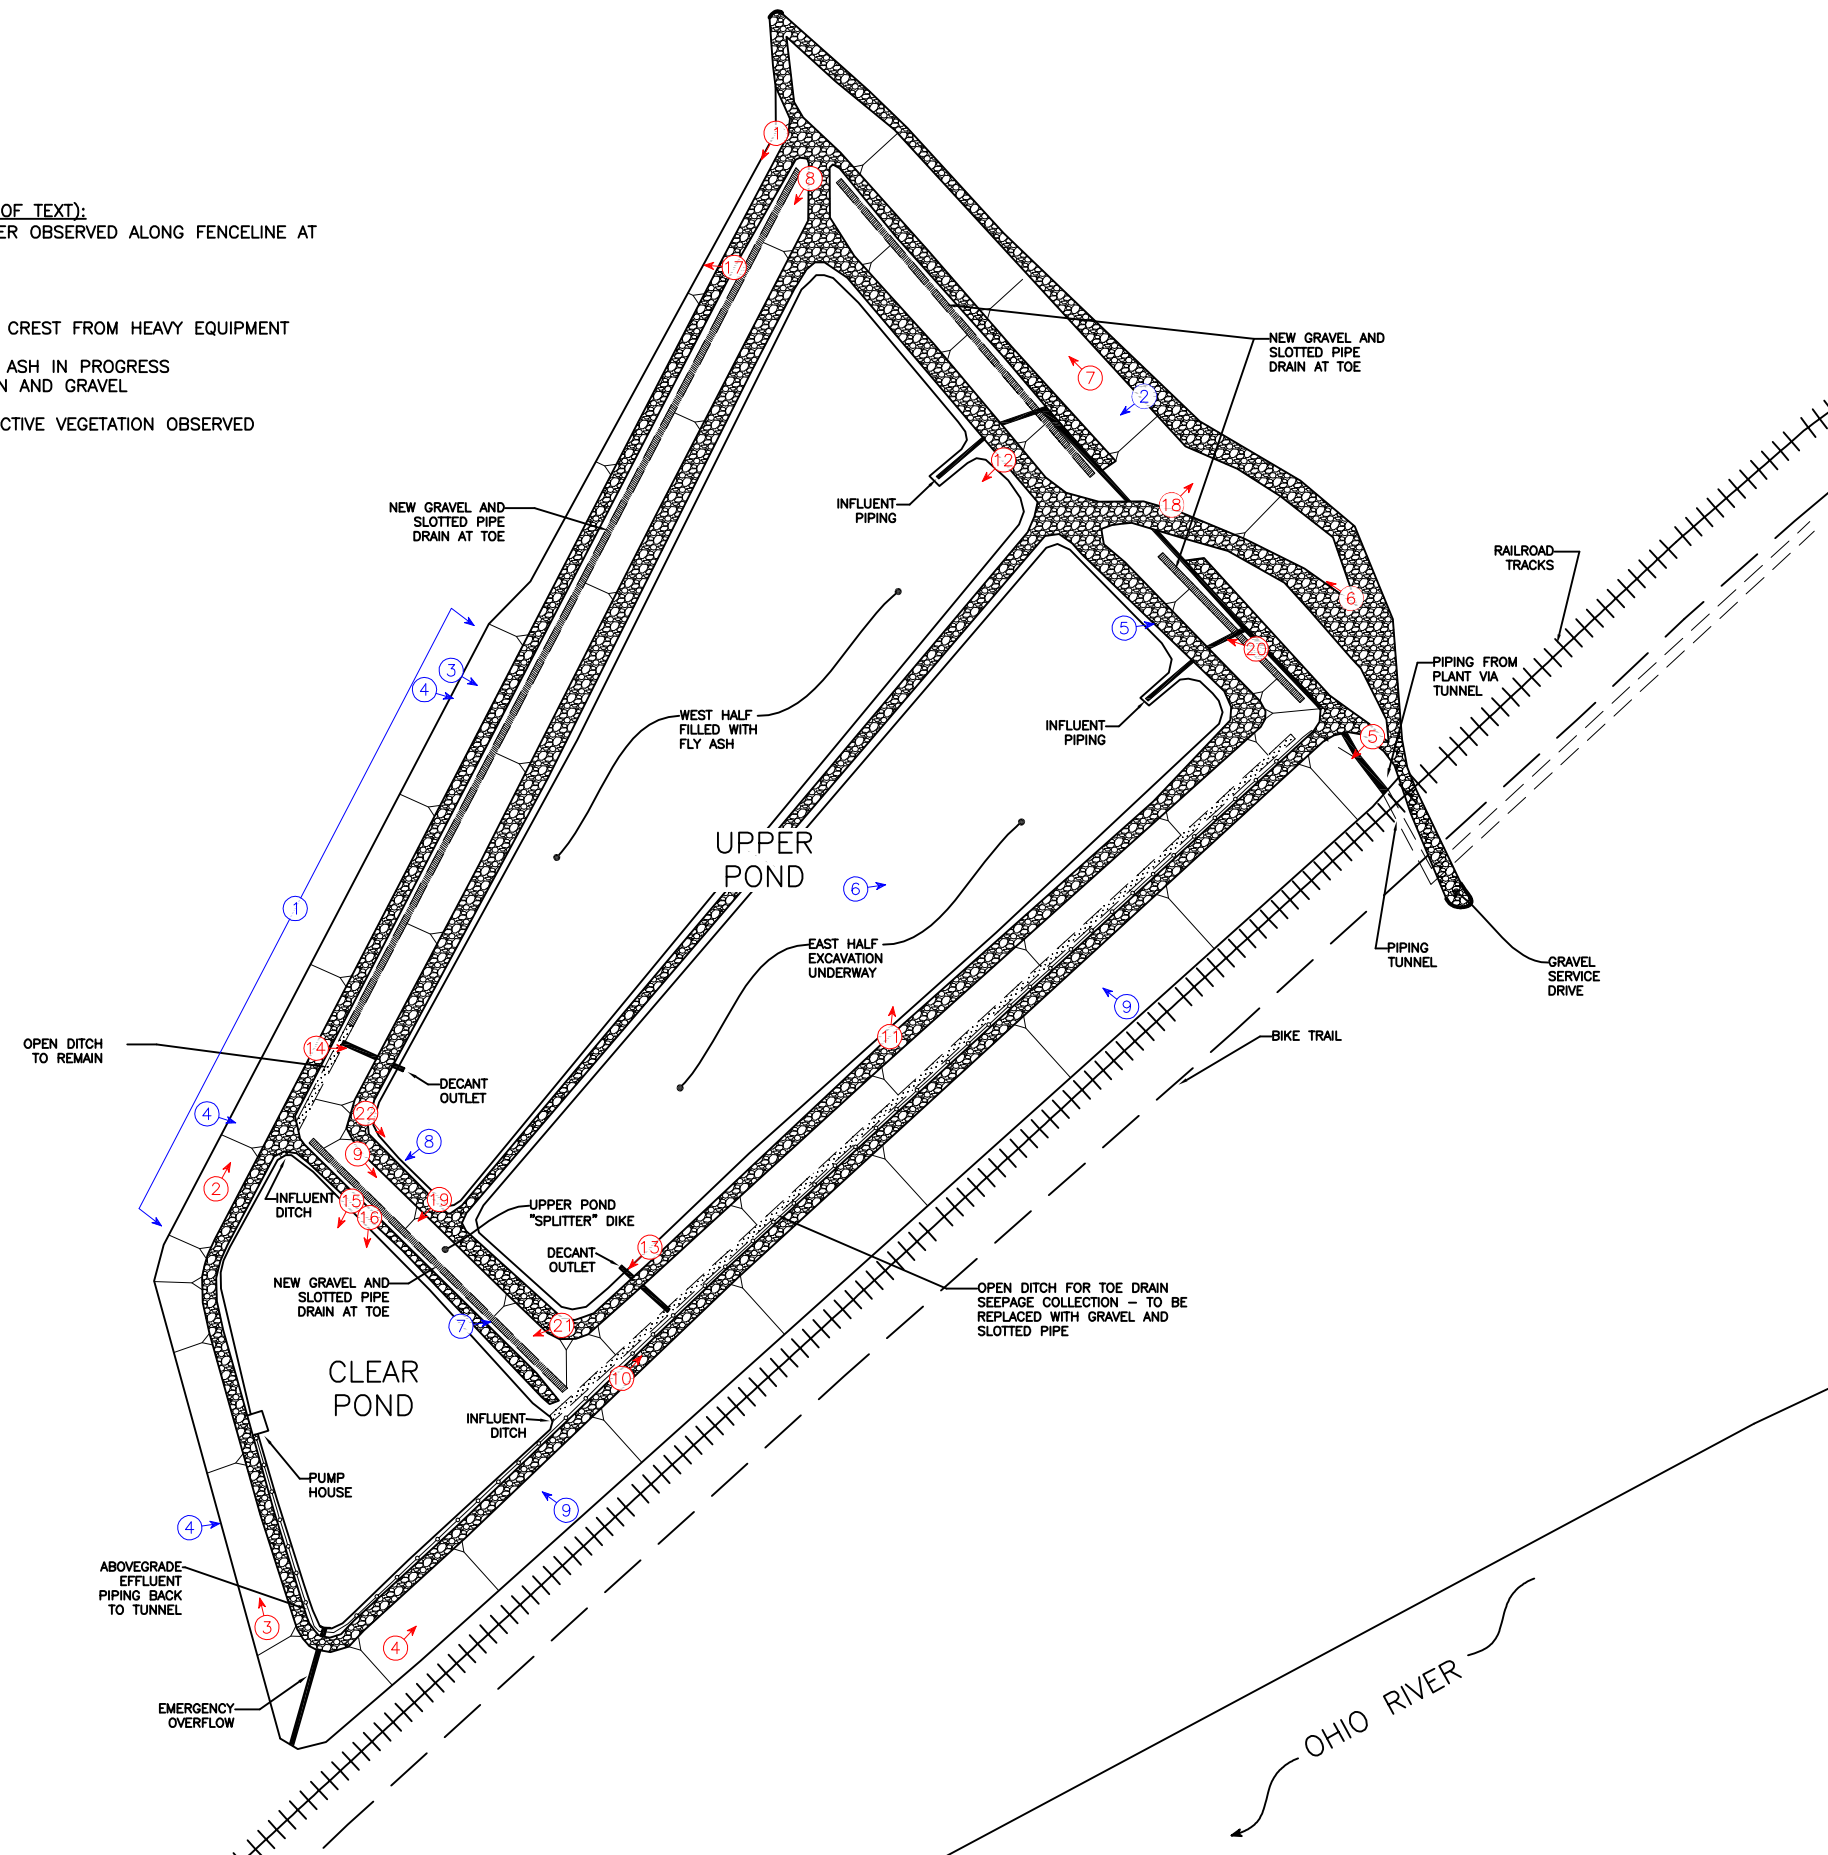
FIGURE 3

OBSERVATION NOTES (ALSO SEE SECTION 4.2 OF TEXT):

1. SHRUBBERY AND TREES UP TO 4" DIAMETER OBSERVED ALONG FENCELINE AT TOE OF WEST EMBANKMENT
2. ISOLATED SEEP
3. MULTIPLE ANIMAL BURROWS
4. ANIMAL BURROW UNDER FENCE
5. ELEVATION DIFFERENCES OBSERVED ALONG CREST FROM HEAVY EQUIPMENT TRAFFIC
6. OBSERVED EXCAVATION OF DEPOSITED FLY ASH IN PROGRESS
7. OBSERVED INSTALLATION OF SLOTTED DRAIN AND GRAVEL
8. MINOR SCARPS OBSERVED
9. EQUIPMENT RUTS AND REMOVAL OF PROTECTIVE VEGETATION OBSERVED

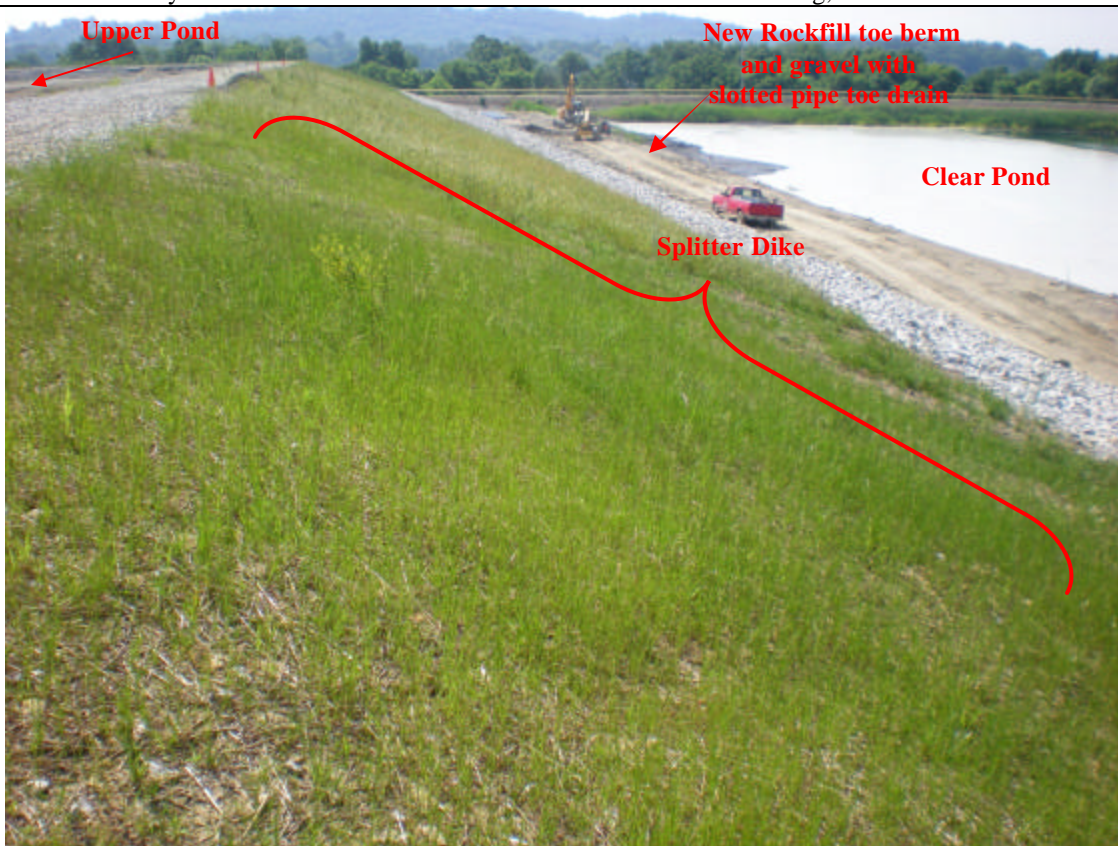
Photo Number:  
9

- The downstream slopes of the new Upper Pond were reinforced with riprap and vegetation in 2006.
- A gravel and slotted pipe toe drain collection system is under construction and will replace the open channel that currently conveys seepage from the Upper Pond embankment toe drain to the Clear Pond. South of the Splitter Dike, an additional rockfill toe berm was added to accommodate installation of the slotted pipe collection system (Appendix B – Photo 9).

Description:  
View along  
splitter dike of  
Upper Pond.  
Clear pond at  
right, Upper  
Pond at top left.

A slotted pipe toe drain system is currently being installed to replace the drainage ditch which currently collects seepage from the Upper Pond. The owner should continue as planned with this modification to improve the conveyance of water away from the toe.

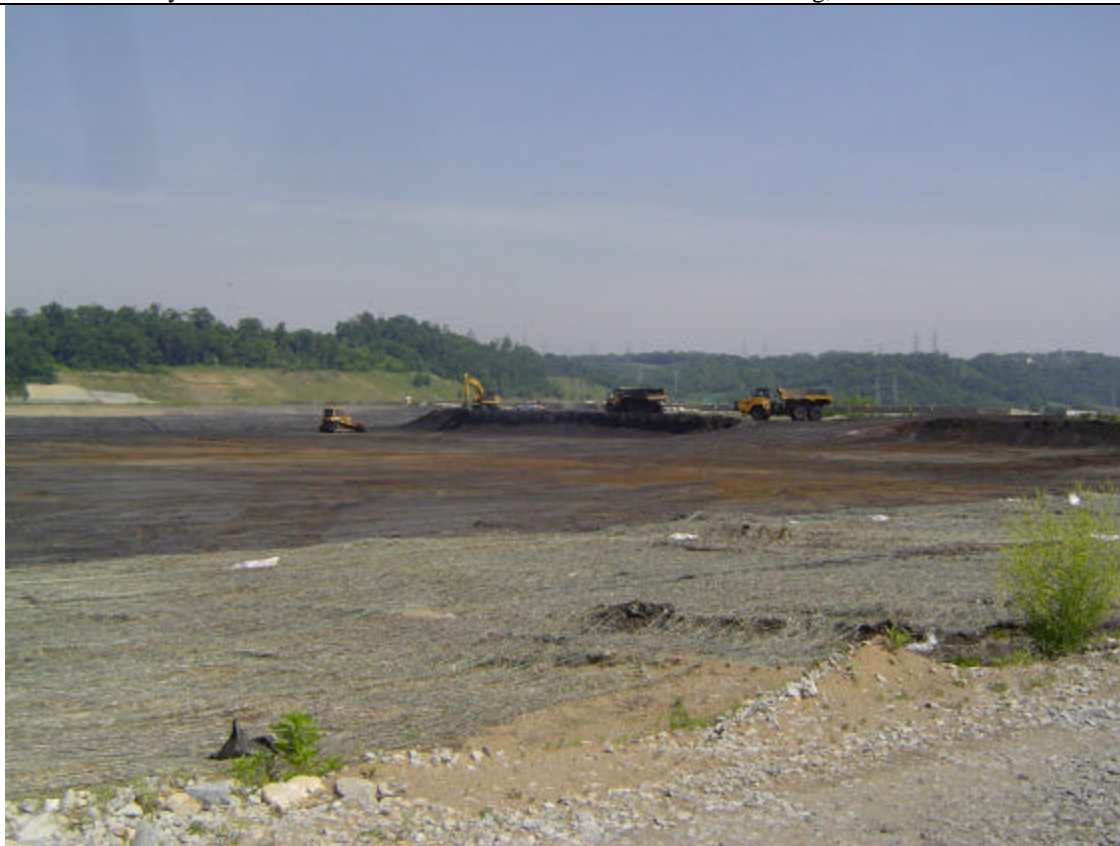
- Minor elevation differences were noted along the crest of the Upper Pond due to heavy equipment traffic.
- Excavation of deposited fly ash was observed at the Upper Pond (Appendix B – Photo 11).

Excavation of stored fly ash from east half of Upper Pond in progress.

Excavated fly ash is destined for facility's new fly ash landfill.

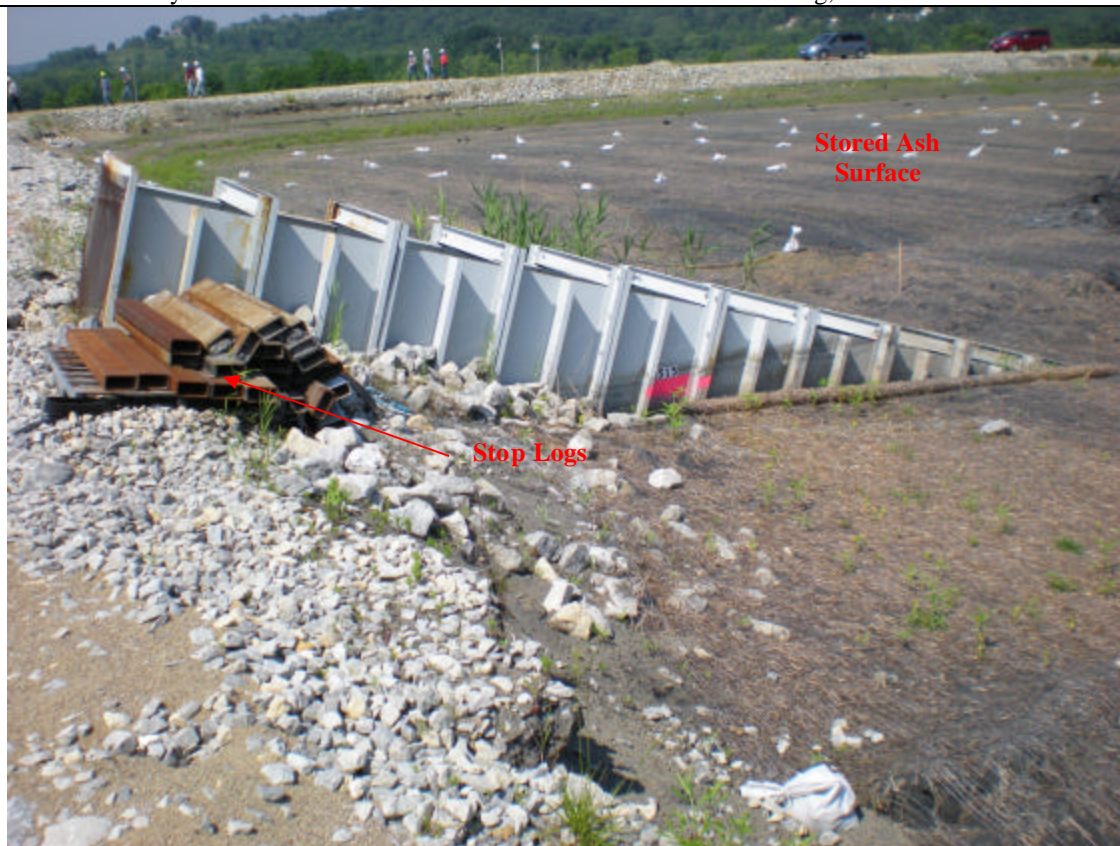
Photo Number:  
 13

Description:  
 Inlet to Upper  
 Pond decant  
 structure. Note  
 stop logs stored  
 at left and  
 stored ash in  
 picture  
 background.

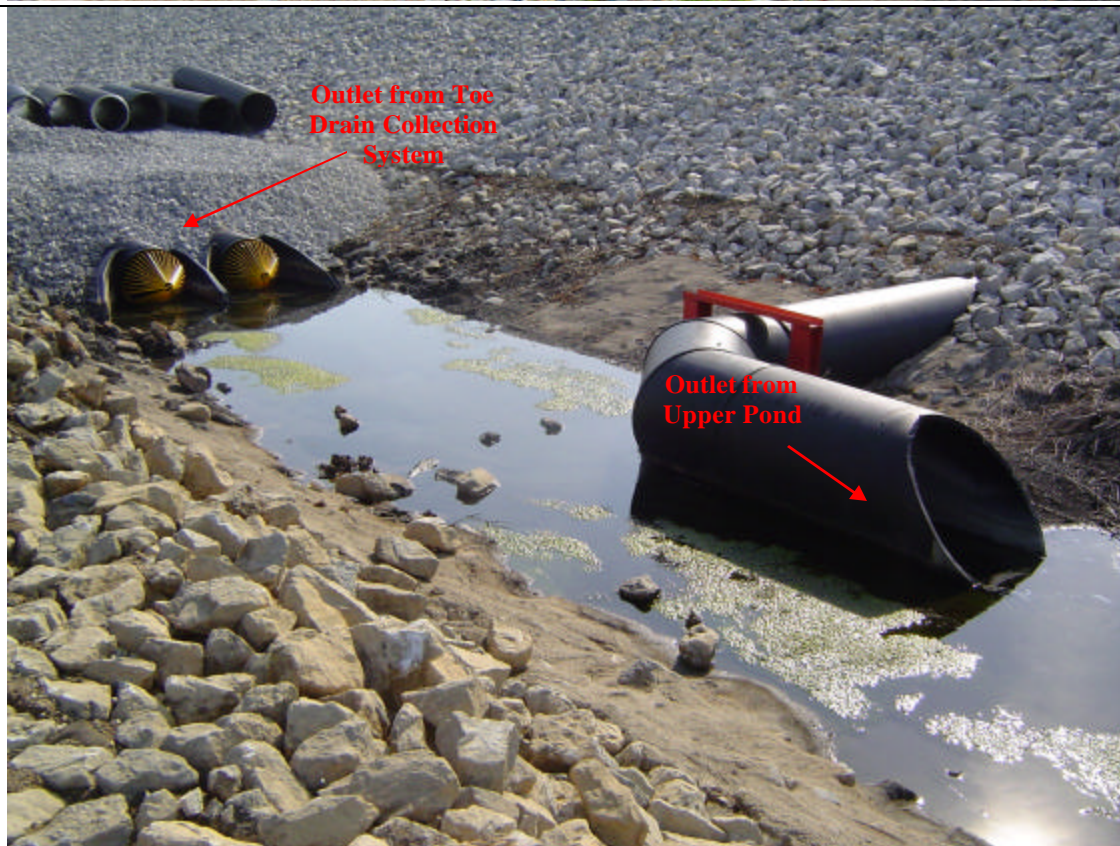
Photo Number:  
 14

Description:  
 Outlet from new  
 slotted pipe toe  
 drain collection  
 system and  
 outlet from  
 Upper Pond into  
 ditch.

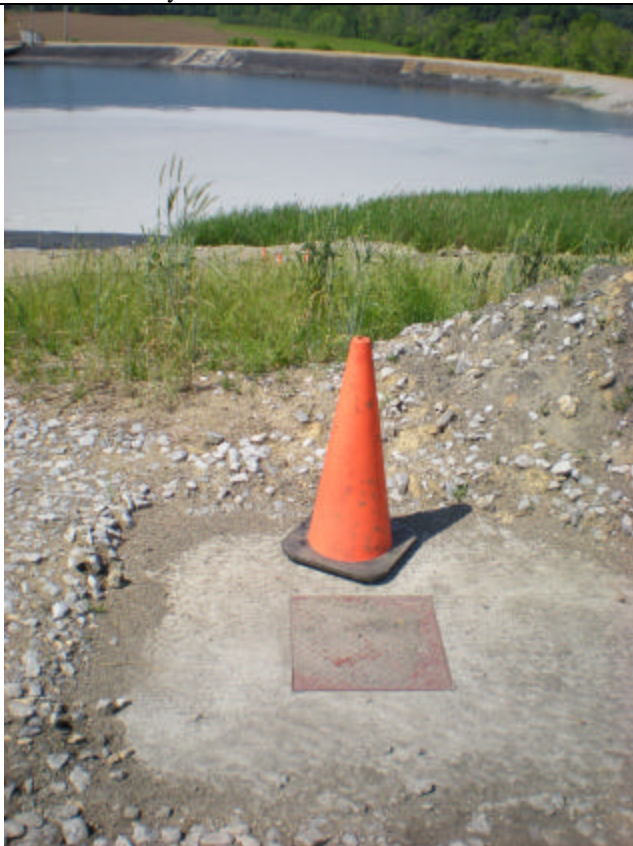
Photo Number:  
19

Description:  
Vault for  
settlement plate  
on crest of the  
Upper Pond  
splitter dike.

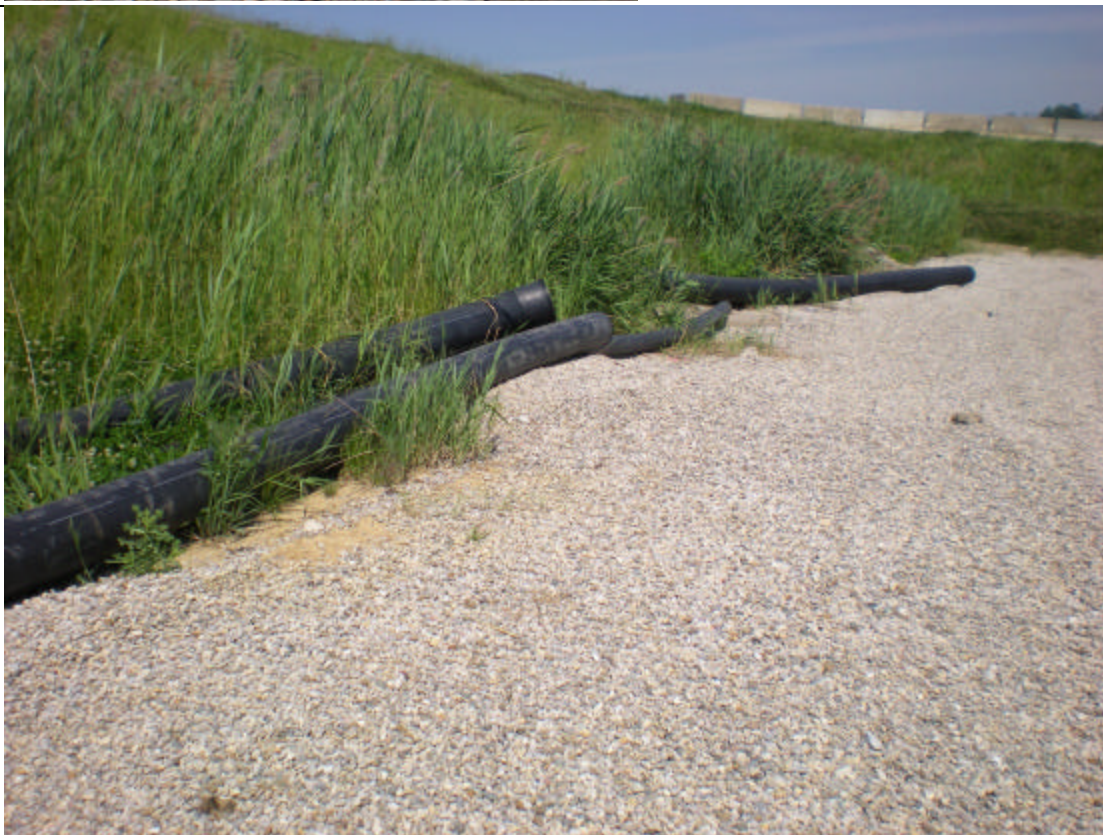
Photo Number:  
20

- An isolated seep of clear water was observed on the north slope near the construction access road (Appendix B - Photo 20).
- Areas rutted by equipment and missing vegetative cover were observed at two locations on the east slope of the original embankments.

Description:  
Wetland type  
vegetation  
growing on  
north side of  
upper  
embankment  
near isolated  
seepage at the  
toe of the slope.

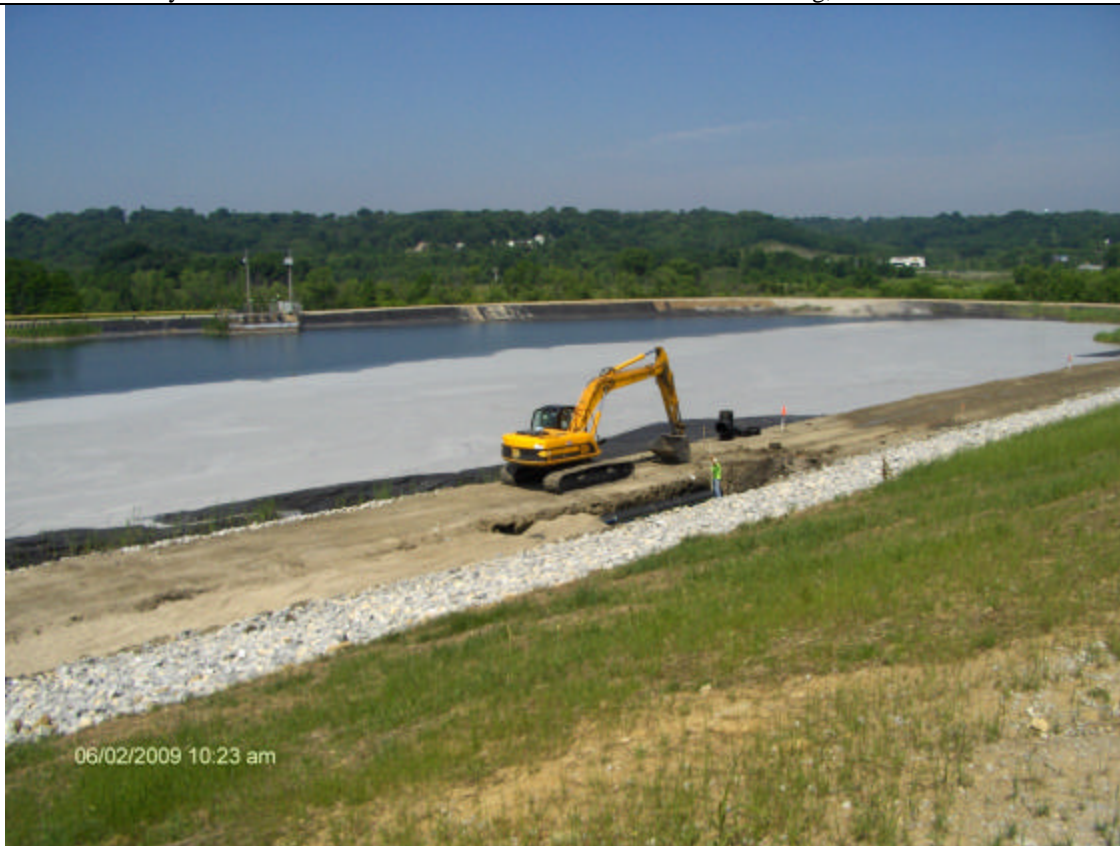
Photo Number:  
 21

- Installation of the new slotted seepage collection system was observed along the splitter dike (Appendix B – Photo 21).
- Minor scarps were observed along the top of the upstream side of the east and south embankment slopes of the Upper Pond. Scarps are typically three feet in height and are made more prominent by the addition of roadway aggregate on the embankment crest (Appendix B – Photo 22).

Description:  
 Installation of  
 slotted pipe toe-  
 drain collection  
 system at toe of  
 Upper Pond  
 splitter dike.

The owner cited a 2009 completion date for the installation of the remainder of the slotted drain pipe system. The owner should continue toward completion of this project as planned.

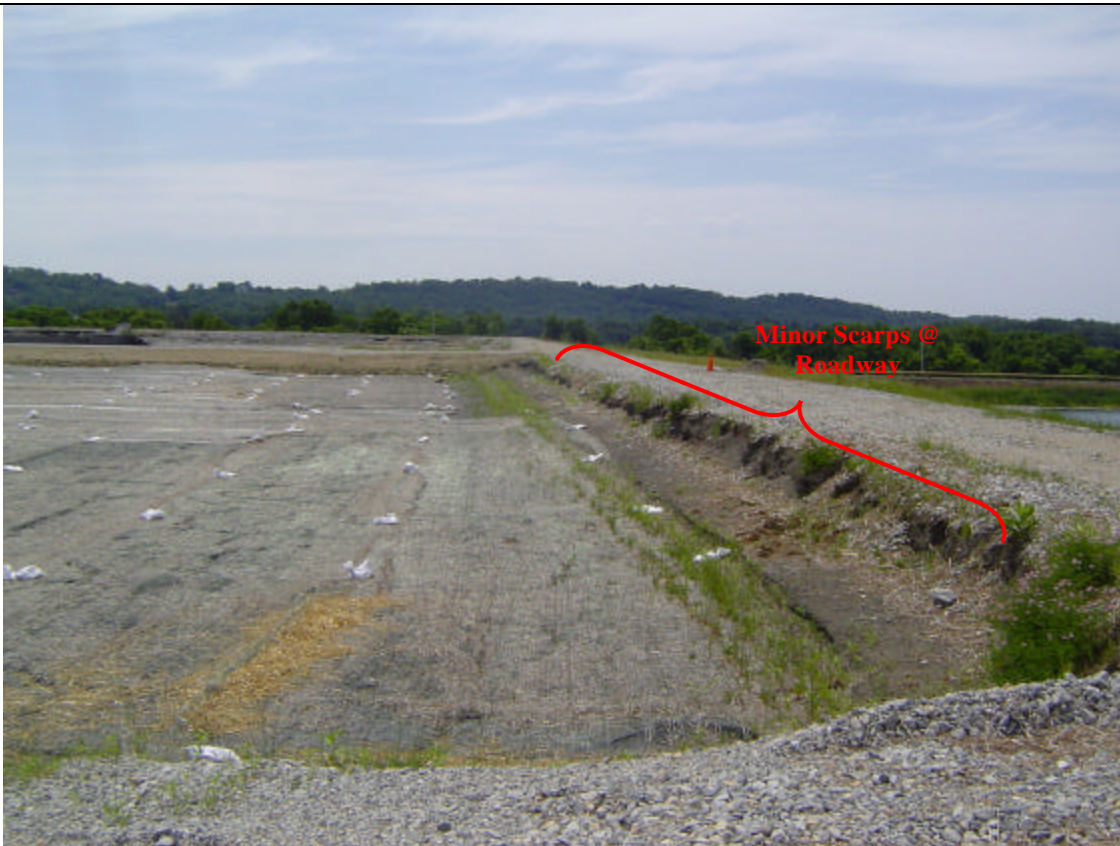
Photo Number:  
 22

17	Numerous minor scarps were observed along the top of the upstream side of the 'east' and 'south' embankment slopes. Scarps are typically 3' in height and are made more prominent by the addition of roadway aggregate on the embankment crest.
20	Fly Ash Pond not in operation at time of inspection
21	The base of the dike is constructed with a porous gravel toe drain that is designed to collect embankment seepage. A slotted drainpipe is currently being installed at downstream toe around perimeter of dike to replace the existing ditch which conveys the embankment seepage to the outlet.
23	During inspection, the upper pond was filled to capacity with fly ash and fully drained of free surface water. However, when receiving new fly ash, or in an extreme precipitation event, the level of the clear pond (lower pool) may be elevated and this water may rest against the toe of the 'south' (splitter) dike.

Description:  
 Minor scarps  
 along roadway  
 on upstream  
 side of Upper  
 Pond splitter  
 dike.
